Fourth Five-Year Review Report for Pickettville Road Landfill FLD980556351

Jacksonville Duval County, Florida

January 2016

United States Environmental Protection Agency Region 4 Atlanta, Georgia

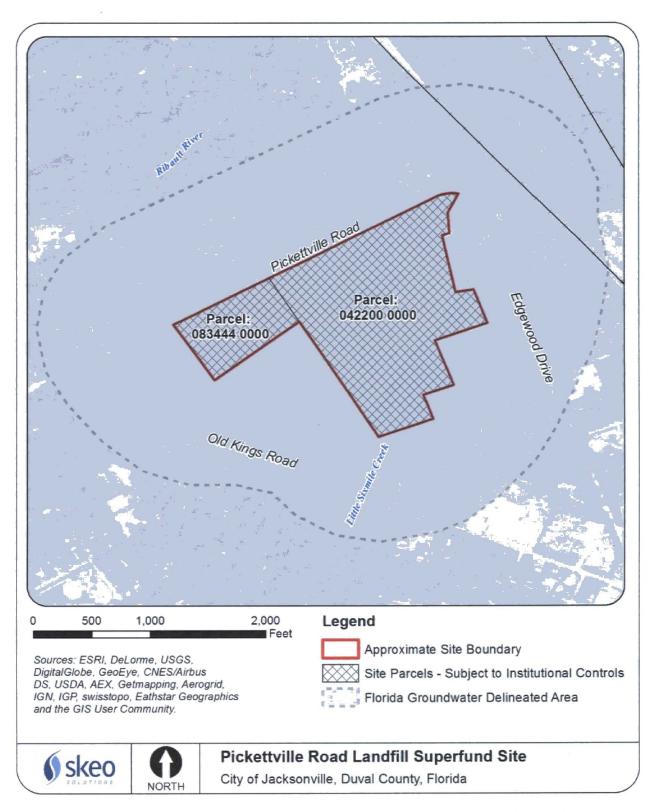
Figure 3: Florida Groundwater Delineated Area

The July 1993 deed restriction serves as an institutional control to restrict groundwater and land use on the Site. It prohibits any use of the Site that would obstruct or disturb the remedy in place. It prohibits use of the site property for residential, commercial, industrial or recreational uses. It also limits construction of buildings or structures at the Site to those related to the selected remedy. The deed restriction also prohibits extraction or use of groundwater from the Site. In July 1993, an easement was signed by the former site property owner to allow the EPA, contractors, consultants and employees to access the Site for remediation activities in accordance with the terms and conditions set in the Consent Decree. The Site is located within a Florida Groundwater Delineated Area, which restricts placing wells on the Site and in areas around the Site within the delineated area (Figure 3).

The City of Jacksonville owns the Site, which includes two parcels, 042200-0000 and 083444-0000. Tables 7 lists the institutional controls associated with areas of interest at the Site. Figure 3 shows the property boundaries for the parcels at the Site with institutional controls.

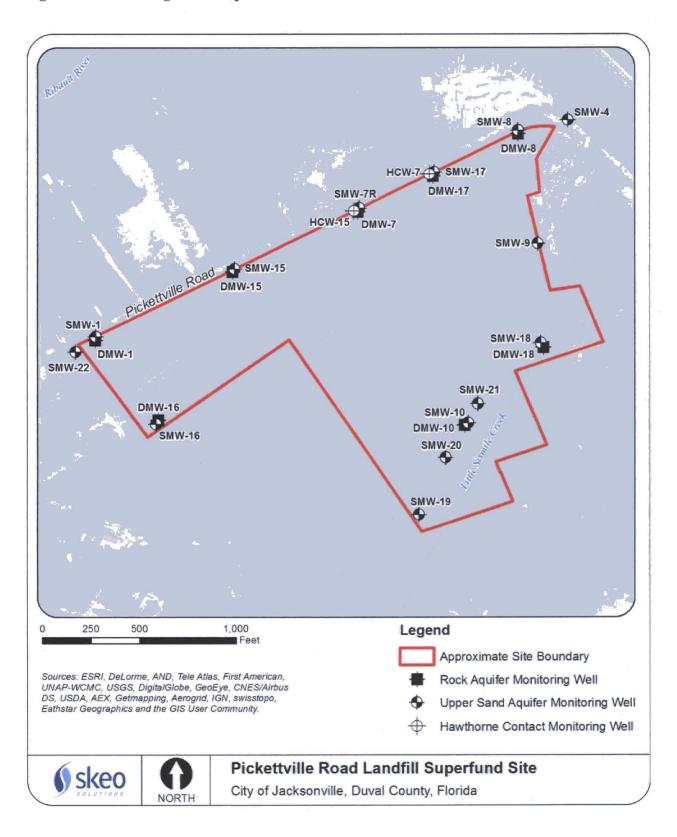
Figure 4: Monitoring Well Map

The PRPs detected several VOCs (1,1-dichloroethene; 1,1-dichloroethane; chlorobenzene; 1,2-dichloroethene; and benzene), but only benzene was above its MCL. Benzene was above its MCL in SMW-17, but the concentrations were below the ACL of 115 μ g/L, which is protective of surface water. The concentrations fluctuate seasonally but generally decline over time. The concentrations in the previous five years ranged from below detection to 6.3 μ g/L in July 2010; the most recent sample collected in October 2014 was 3.2 μ g/L (Figure 5).

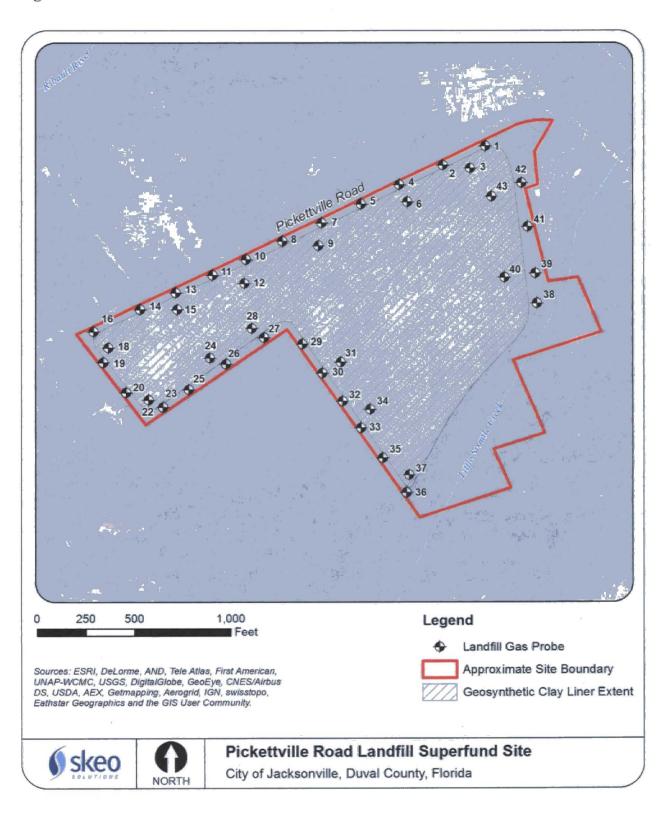
Figure 6: Landfill Gas Probe Locations

The gas collection trench extends along the landfill perimeter except for the side next to Little Sixmile Creek. The gas monitoring system consists of 41 gas probes (GP-1 to GP-43; based on field conditions, GP-17 and GP-21 were not installed). The PRPs installed probes about every 200 feet outside the trench, and every 400 feet inside the trench (Figure 6). The PRPs conduct landfill gas monitoring on a semi-annual basis. During these events, the PRPs sample gas probes for methane and inspect the landfill area for evidence of gas seepage, such as stressed vegetation, cracks in the surface layer, and unusual odors. A review of gas monitoring data from February 2011 to March 2015 indicates that the system is functioning as designed. Although several gas probes inside the gas collection trench had measurements above the lower explosive limit (LEL), measurements outside the gas collection trench were below the action level of 5 percent for methane. This indicates that gas is not migrating from the landfill. However, GP-42, located outside the gas collection trench, routinely had measurements above the LEL throughout the last five years. This probe is near former leaking underground storage tanks (USTs) at the LTPC property. The detections are likely associated with soil contamination from these USTs. This observation has been consistent since the first FYR.
